THE CALIFORNIA EARTHQUAKE OF 1906

T h e
California Earthquake
of 1906

Edited by
David Starr Jordan

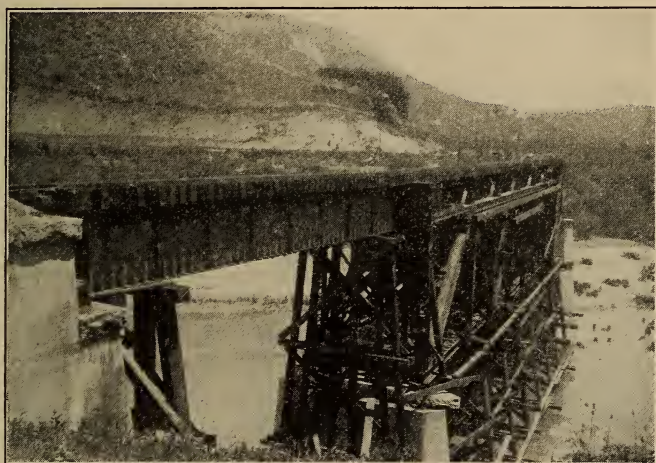
FIG. 49—Pájaro River Bridge, Southern Pacific Railroad; Temporarily Strengthened by Timber Bents and False Work; View Taken May 30, 1906.

It is on a six-degree curve whose chord makes an angle of about 40° with the fault line. The fault crosses the bridge near the west end. The bridge consists of two end deck-plate girder spans of fifty feet each, and four intermediate deck Pratt trusses, each of 120-feet span; Fig. 49. The abut-

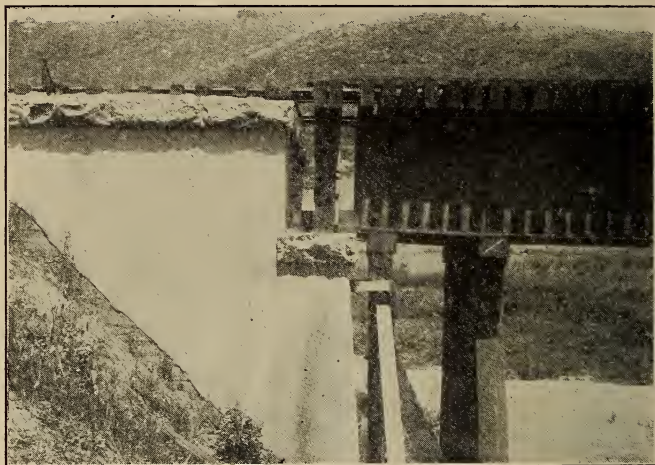
FIG. 50—*West Abutment, Pájaro River Bridge, Southern Pacific Railroad.*

racking, since the ground upon which its piers rested moved unequally. The distance between the end piers was increased $3\frac{1}{2}$ feet. All the piers and abutments were moved more or less, but the heaviest movements occurred at the west end of the bridge. Fig. 50 shows the west abutment where the steel plate girders were moved 24 inches off the abutments and had to be supported by a

eastward relatively more than 20 inches. The segmental rollers and the steel pedestals upon the coping were smashed and the anchor bolts severely bent. The next intermediate pier leaned somewhat to the east, and the anchor bolts above the coping were bent so that the pedestals of the steel work were moved some three inches. The distortion was less as one approached the eastern end of the structure. The eastern abutment was considerably cracked. The whole bridge superstructure was thrown slightly out of plumb. Earth motions are clearly seen in Fig. 50, where the sloping earth was moved 18 inches along the side wall of the west abutment.

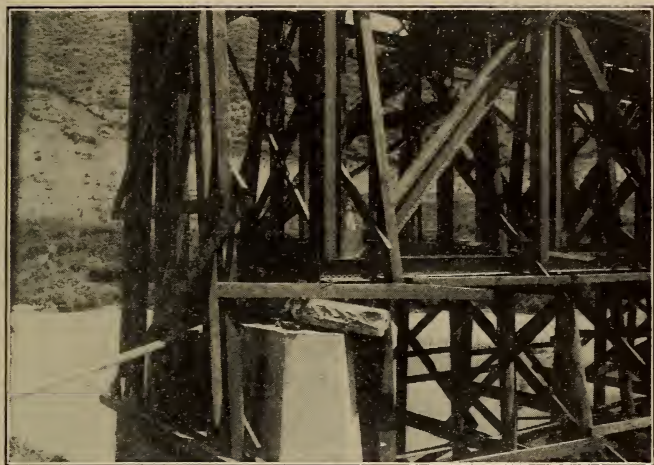
FIG. 51—*First Intermediate Pier, West End, Pájaro River Bridge, Southern Pacific Railroad.*

east. Fig. 51 shows the first intermediate pier at the west end of the bridge. This pier near its base was ruptured in a horizontal section, probably a level between two days' concrete work. The mass of the pier above the rupture was moved eastward about three inches with respect to the base. The coping was ripped from the top and moved

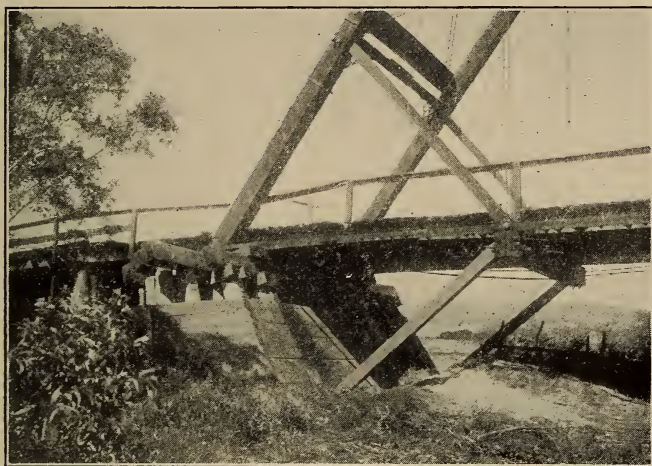
direction a distance of about six feet. Fig. 52 shows the south abutment of the Salinas highway bridge. The ground under the superstructure moved about six feet, careening the pile foundations as shown in the picture, without seriously injuring

FIG. 52—*South Abutment, Salinas Highway Bridge.*

the trusses. A three-inch oil pipe line which crossed the bridge was ruptured on the south approach, one length of pipe being bent to form the letter "S." The northern approach to the bridge was hardly affected. In fact, the northern bank of the river shows little disturbance at this point. From the Salinas bridge eastward, a distance of about $1\frac{1}{2}$ miles to Spreckels, the south bank of the river is

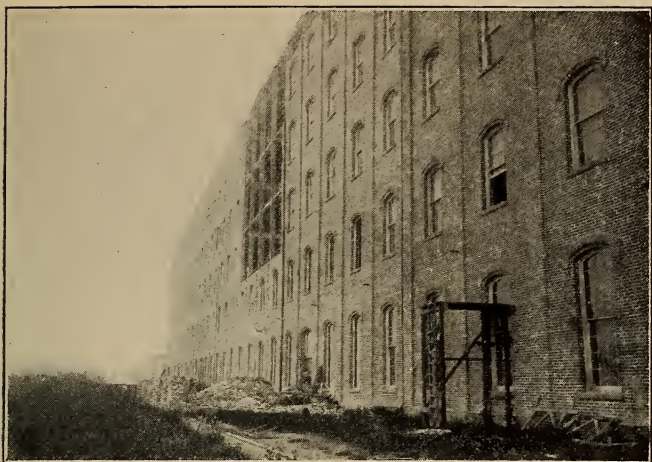
FIG. 53—West Wall, the Spreckels Sugar Mill, near Salinas, Showing Bulged Wall and Brickwork Thrown from the Steel Frame.

The east wall was buckled concave outward, and was badly cracked, but little of it fell. The west wall, in the middle third, was buckled convex outward, and naturally the brick work was thrown down in large masses. Fig. 53 shows the west

wall of the building. I believe this building was subjected to an earth movement from south to north, which accounts in a measure for the buckling of the long walls in the middle unsupported third. There may have been some settling of the walls also. Large masses of brick in the north wall, Fig. 54, were thrown down. Fig. 55 shows a rupture in the carriage way to the dumps at the south

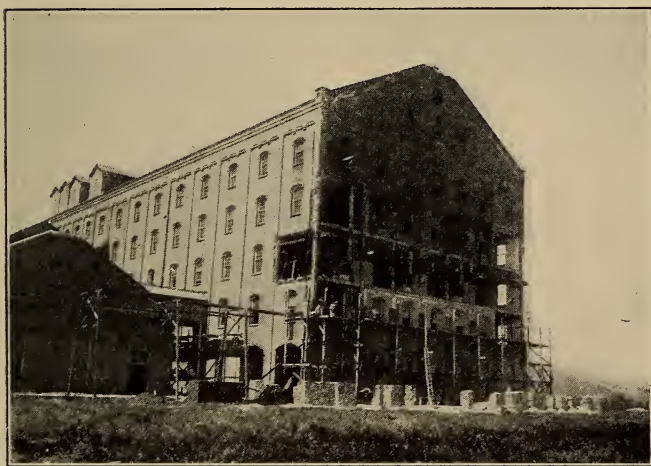
FIG. 54—North Wall, the Spreckels Sugar Mill, near Salinas, Showing Ruptured Brick Curtain Walls and the Advantages of a Class A Steel Frame.

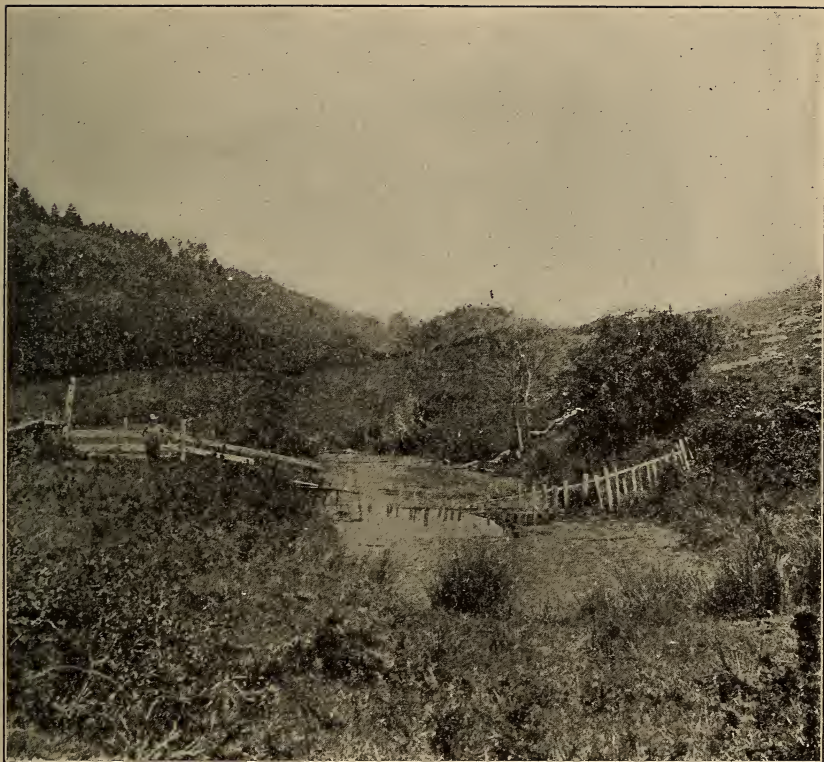
FIG. 2—*Fault Topography between Tomales and Bolinas Bays; Looking Northwest. The General Slope Toward the Left Has Been Interrupted by a Slight Uplift of the Part at the Left. The Pond Occupies a Hollow Thus Produced.*

and to obliterate the lakes by cutting down their outlets or filling their basins with sediment. Fig. 2 shows one of the fault-made ponds. This line and zone have been recognized by California geologists through a distance of several hundred miles. It was to this line that attention and expectation were especially directed, and it was on this line that the surface evidence of new faulting was actually found. The new movement was not coextensive with the line as previously traced, but affected only the northwestern portion; and, on the other hand, it extended farther to the northwest and north than the old line had previously been recognized. The map represents only the line along which the recent change occurred. From a point a few miles southwest of Hollister it runs northwestward in a series of valleys between low mountain ridges to the Mussel Rock, ten miles south of the Golden Gate. Thence northwestward and northward it follows the general coast line, alternately traversing land and water. The farthest point as yet definitely located is at Point Delgada, but the intensity of the shock at the towns of Petrolia and Ferndale probably indicates the close proximity of the fault and warrants the statement that its full length is not less than three hundred miles. South of Point Arena its course is direct, with only gentle flexure, but the data farther north

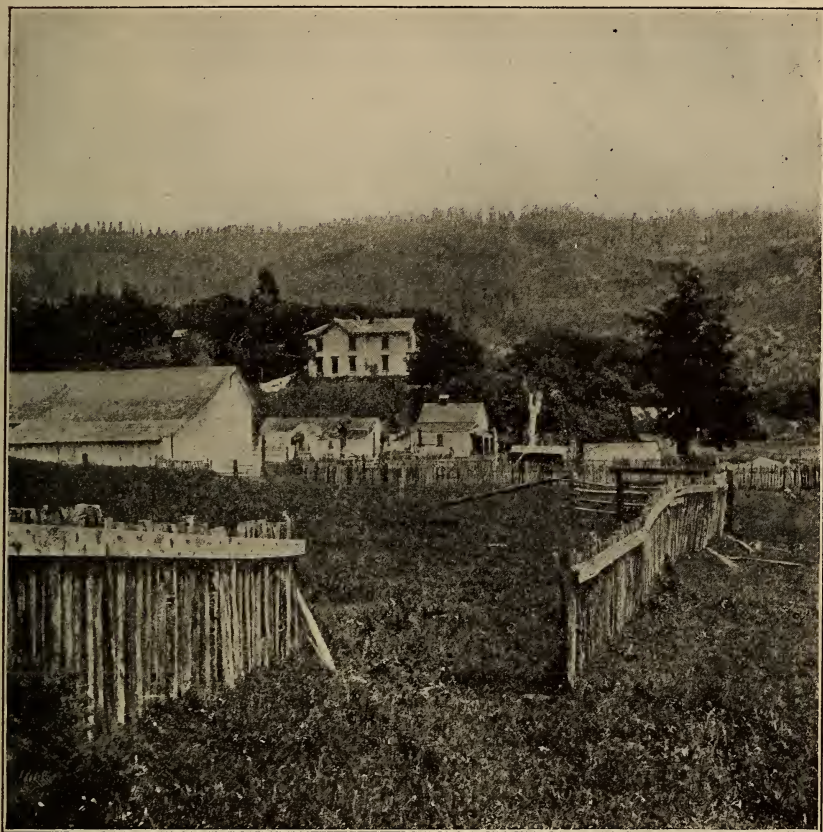
FIG. 3—This Fence, Previously Continuous and Straight, Was Broken and Parted by the Earthquake Fault, the Offset Being $8\frac{1}{2}$ Feet. The Line of Fault, Concealed by the Grass, Crosses the Ground from Left to Right, Touching Both the Dissevered Ends of the Fence.

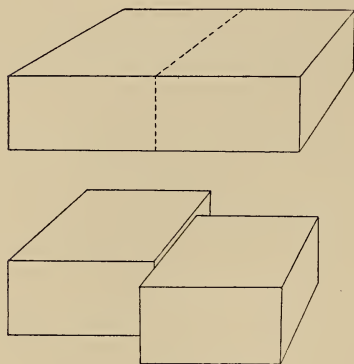
FIG. 4—*Diagrams Illustrating the Dislocation Causing the California Earthquake. The Upper Represents an Earth Block 100 Feet Square and 25 Feet Thick, with Indication of the Position of the Fracture. The Lower Shows the Relation of Its Two Parts after Faulting.*

That which occurred along this line was a differential movement and permanent displacement of the rock and earth on the two sides of a vertical crack. The principal displacement was not vertical, but horizontal. If one thinks of the land to the east of the crack as stationary, then the change may be described as a northward movement of the land west of the crack. If the land to the west be thought of as stationary then the land to the eastward moved toward the south. It is probable that both tracts shared in the movement, the eastern shifting toward the south and the western toward the north. Perhaps the nature of the change can be more readily understood by reference to Fig. 4, which represents an ideal block of the earth's crust, 100 feet square on the surface and 25 feet deep, before and after its division and dislocation by the earthquake-causing fault.

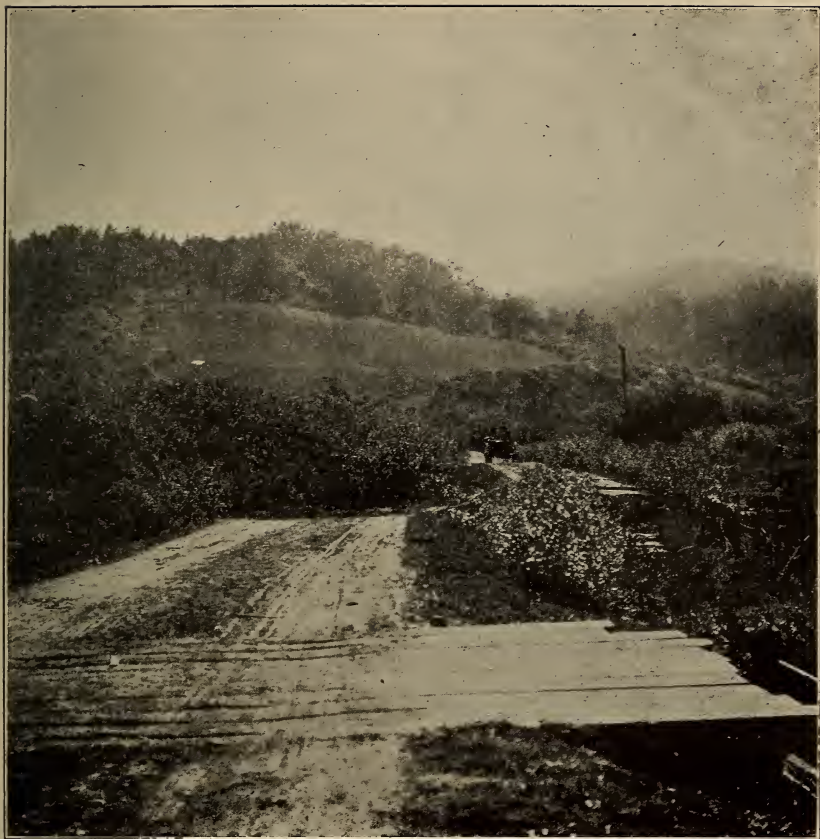
FIG. 5—A Faulted Road near the Head of Tomales Bay. The Nearer and More Distant Parts of the Road Were Originally in One Line—a Continuous, Straight Road. The Present Offset is Twenty Feet.

of about 10 feet. At one place (Fig. 5) a road was offset 20 feet, but in this case the underlying ground was wet alluvium and part of its movement may have been due to a flowing of the soft material. There was also some vertical change, but this was not everywhere in the same direction and its amount was comparatively small. At many points the land west of the fault appears to have risen one or two feet as compared with the land at the east.

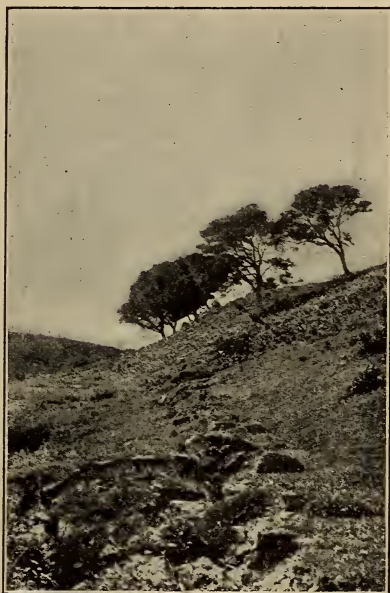
FIG. 6—*Ordinary Appearance of the Earthquake Rift Where It Traverses Firm Turf.*

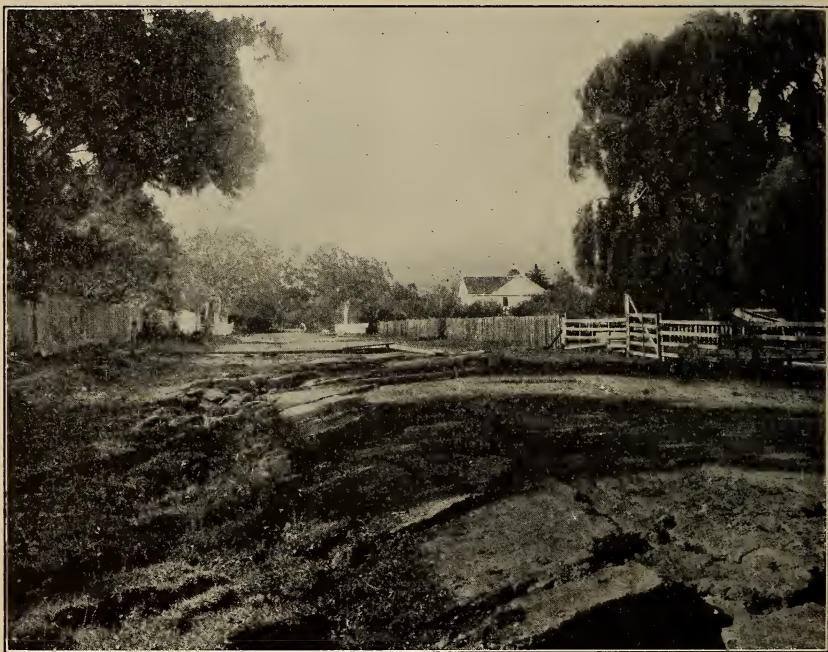
FIG. 7.—A Zone of Earthquake Fracture Where It Crosses a Road Near Bolinas.

angles and gradually dying out in the adjacent country, and in some of these the belt of disturbance is broad and complicated (Fig. 7). There are also outlying cracks occurring within a mile or two of the central rift and having irregular courses, and these may probably be referred to the same general system of rock strains.

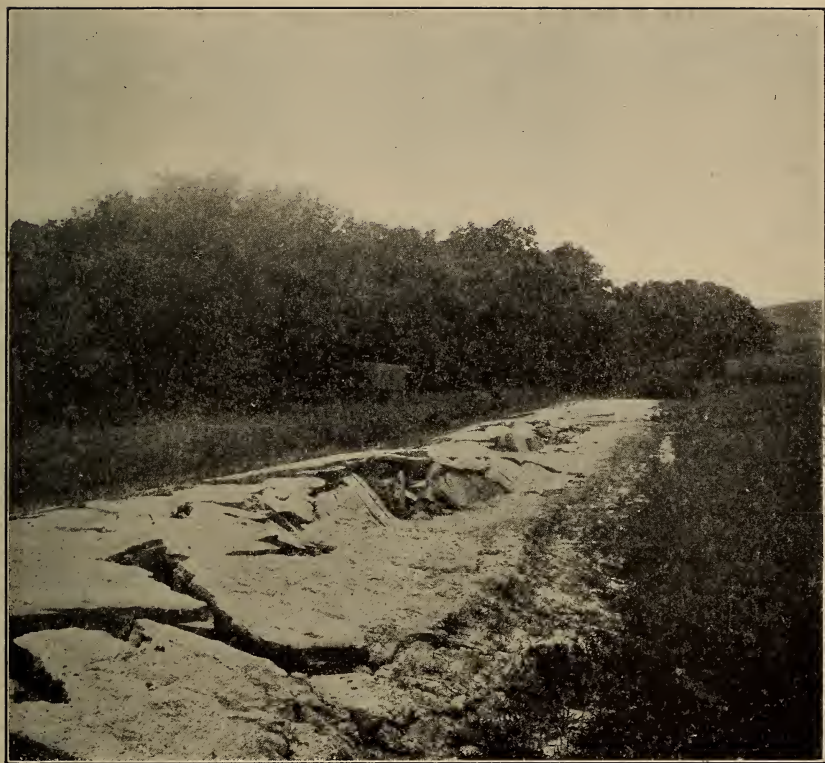
FIG. 8—Cracks Caused by the Shaking of Marshy Ground. The Comparatively Firm Road Embankment Preserved the Cracks Better than the Bog.

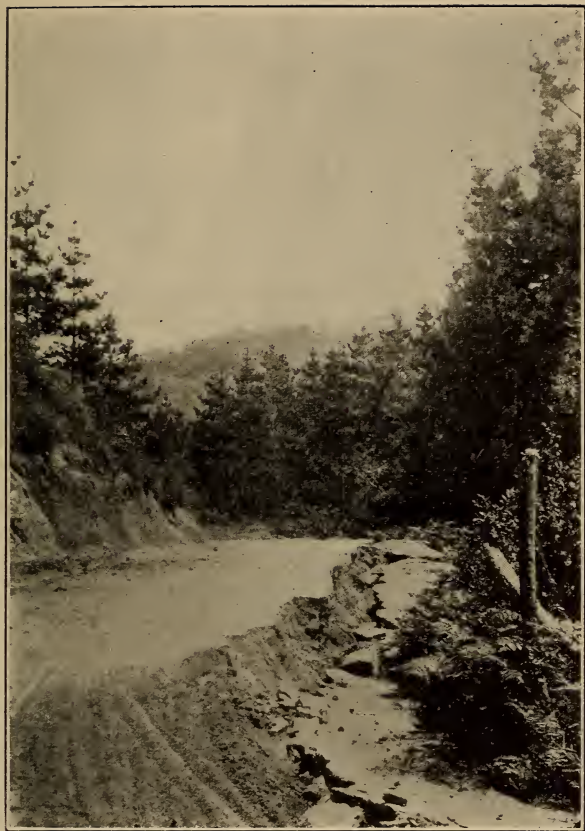
FIG. 10--Road Crack Caused by the Earthquake.

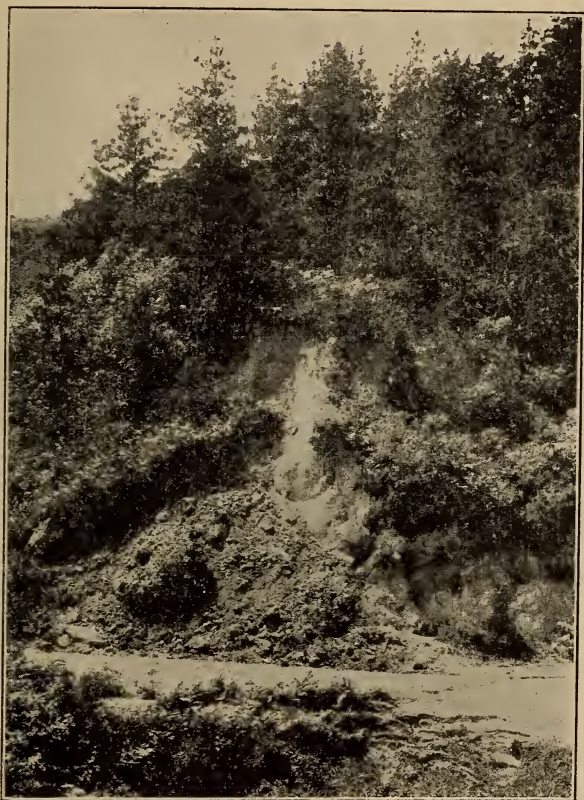
Certain changes, very conspicuous to the observer who drove about the country, are closely associated with roads. A side-hill road is usually constructed by excavating a notch in the natural slope and piling the excavated material in an embankment at the outer edge of the notch. In course of time, and especially during rainy seasons, the embankment at the outer edge of such a road settles and has to be built up as a matter of repair. Portions of the bluff on the up-hill side of the notch are also apt to fall away, taking the form of small landslides, which have to be removed from the road as a rule after every rainy season. The earthquake precipitated many changes of this sort. Along all side-hill roads in the immediate vicinity of the rift a crack was developed between the embankment and the original soil against which it rested, and this crack often assumed formidable dimensions (Fig. 10); in fact its magnitude was found to be a convenient index of the local violence of the earthquake in regions where buildings are rare. Landslips from the bluffs margining the roads (Fig. 11) were also very numerous, in many instances

FIG. 11—*Small Landslide on the Uphill Side of a Side-Hill Road.*

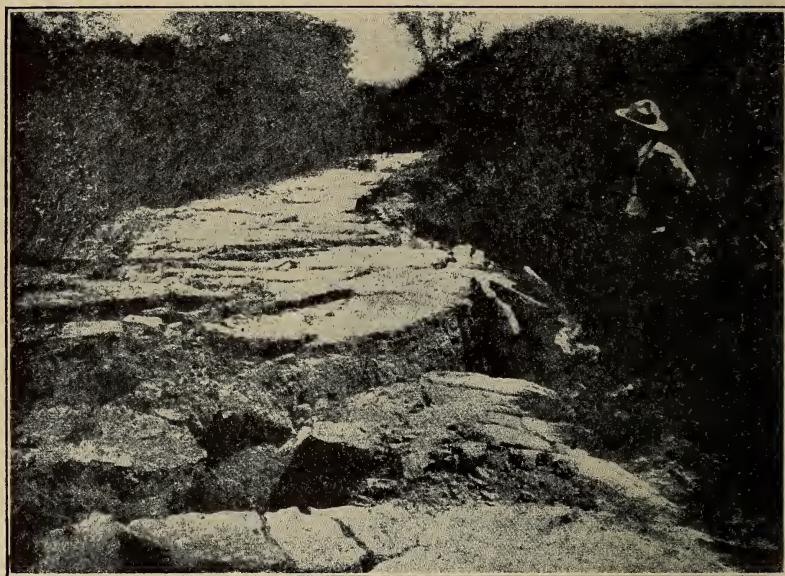
FIG. 3.—Road Crossing the Fault Line Two Miles Southeast of Portolá. There Is a Vertical Uplift on the Northeast Side of the Fracture at This Place.

northeast, or a small downthrow on the southwest, or both. The lateral displacement is well defined, as far as it has been traced, and at some points amounts to as much as 9 feet. The vertical displacement in most places is not so evident, but about a mile southeast of Portolá there is an uplift

of 2 feet on the northeast side, and the same amount of vertical displacement has been observed on Black Mountain.

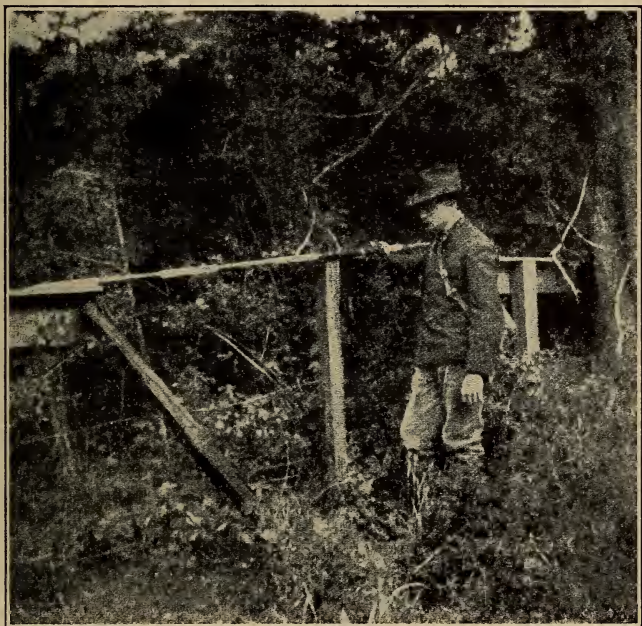
FIG. 4—Showing a Fence That Crossed the Fault at an Oblique Angle. The Post Shown in the Photograph Was Split and Pulled Apart and the Wires Broken.

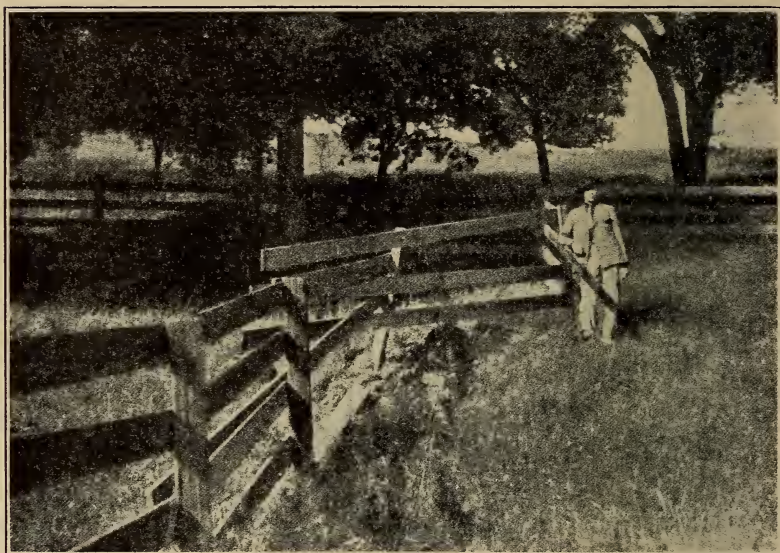
FIG. 5—Showing a Fence That Was Broken and Offset Eight Feet Where It Crossed the Fracture.

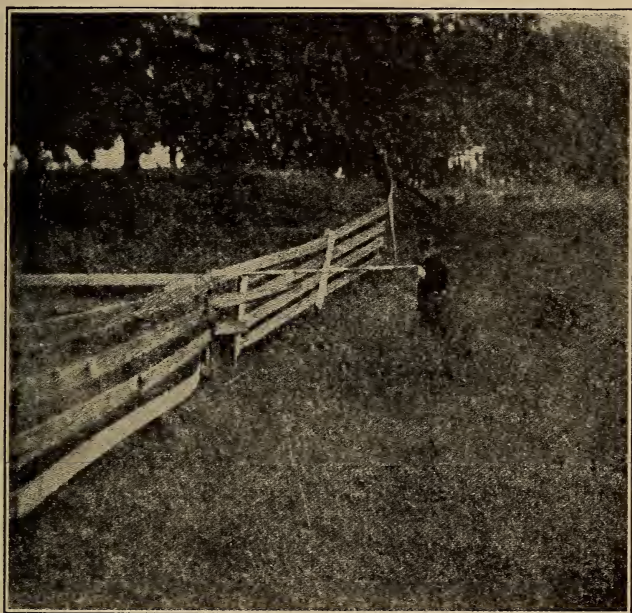
FIG. 6—*Photograph of a Fence Crossing the Fault-Line at Right Angles. The Man is Holding an Eight-Foot Transit Rod and Stands in Line with Continuation of the Fence on the Far Side of the Fracture. The Fence Was Repaired Before the Photograph Was Taken.*

The photograph (Fig. 6) shows a line fence crossing the fault a mile southeast of Woodside. This fence was broken and displaced over 8 feet, but had been repaired before the photograph was taken. The man at the right in the picture is holding an 8-foot transit rod, and he is standing in line with the continuation of the fence on the far side of the fracture. The crack crosses the fence just back of where he is standing.

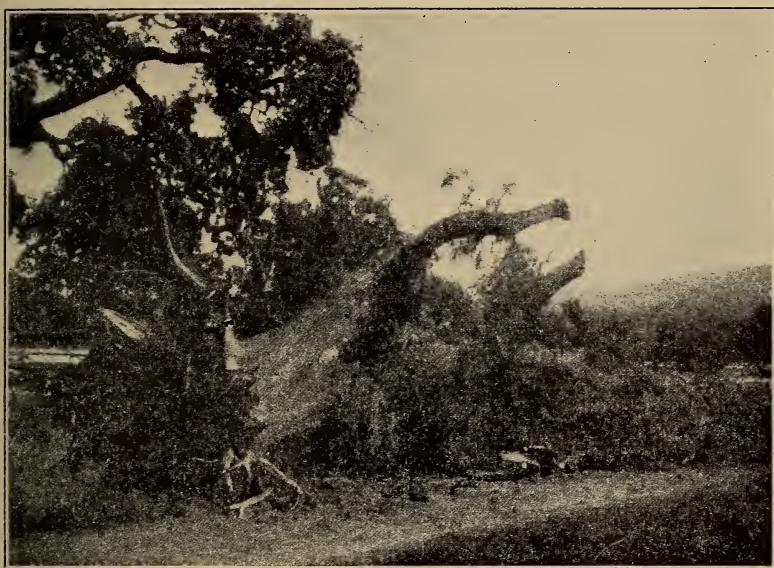
FIG. 8—*An Oak Tree Six Feet in Diameter Uprooted by the Earthquake Three Hundred Yards from the Fault Line.*

There are many white oaks (*Quercus lobata*) growing in the valleys through this section of the country, and in a belt extending for not more than 400 or 500 yards on each side of the fracture many of these trees have been uprooted or have had large

branches whipped off. Sound limbs 2 feet thick were broken off by the shock, and there are trees having a diameter of more than 6 feet that were overturned during the earthquake. About 300 yards southwest of Searsville Lake a live oak (*Quercus agrifolia*), growing within a few feet of the fracture, was split down the trunk by the violence of the movement, but is still standing.

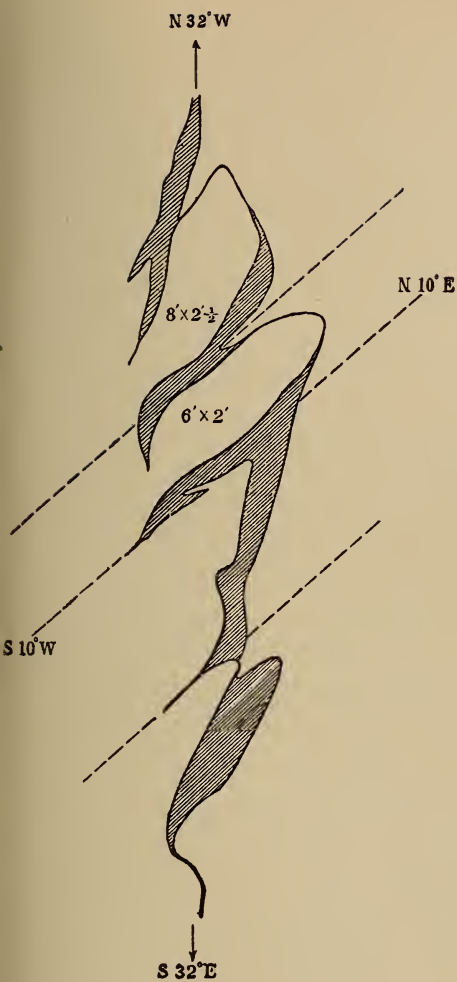
Figs. 8, 9 and 10 show parts of the fault lines found near the town of Manchester, not far from Pt. Arena; the dotted lines in each figure indicating the directions of the secondary shear cracks. Fig. 8 is the plan of the remarkable disturbances shown in Fig. 13. In Figs. 9 and 10, the angle between the main fault line and

FIG. 8—The Shaded Parts Indicate Cracks of the Ground.

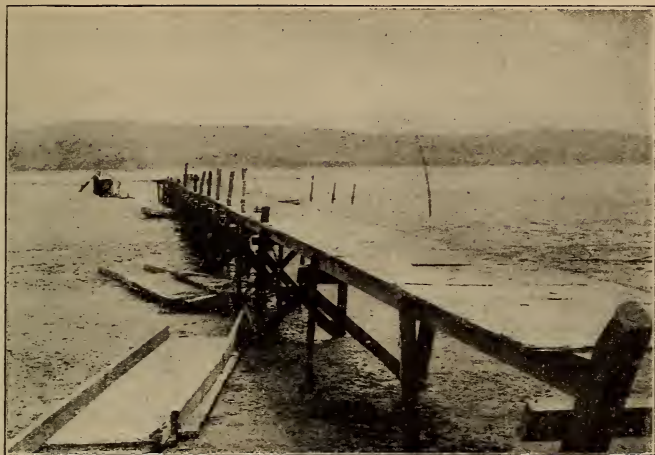
Fig. 11 (Pl. III) shows the shearing effects on a pier at Inverness, on the west coast of the Tomales Bay. The end part of the pier was separated from the rest and was displaced about 20 feet toward NNW. The direction of displacement in this particular instance was opposite to the general direction of the relative slip along the great fault line.

FIG. 11—The Shearing Effects on a Pier at Inverness, on the West Coast of the Tomales Bay. The End Part of the Pier Was Displaced About 20 Feet Towards NNW.

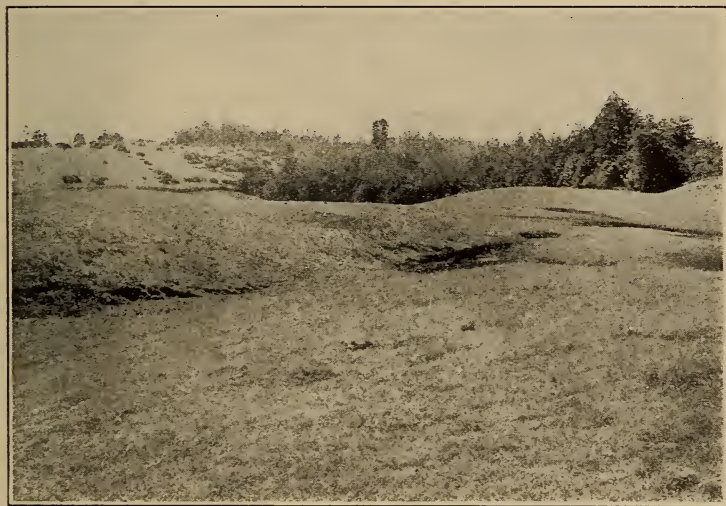
Fig. 12 (Pl. III) shows one of the fault cracks produced among the hills above Fort Ross. It will be observed that the new disturbances appeared along a depression marked by a series of small ponds (shown at the right-hand side of the cut),

FIG. 12—One of the Fault Cracks Produced Among the Hills Above Fort Ross. The New Disturbances Appeared Along a Depression Marked by a Series of Small Ponds (Shown at the Right-Hand Side of the Picture), Which Are Traces Left by a Former Earthquake.

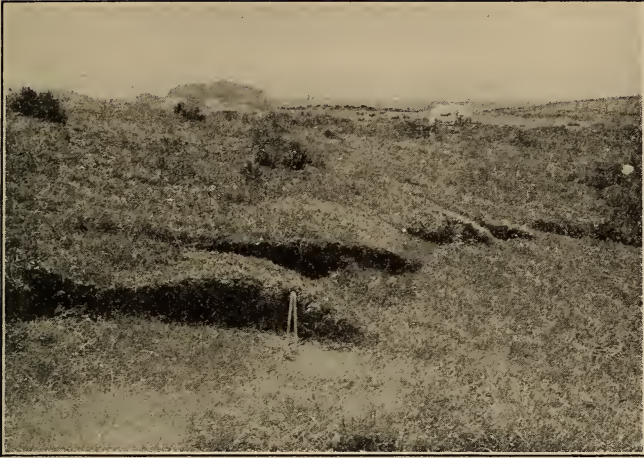
Fig. 13 shows the remarkable compression and shear effects along one of the parallel fault cracks, observed on elevated grounds near the town of Manchester, not far from Pt. Arena. A foot-scale placed in the foreground will show the size of the overlapping earth pieces, whose plan is given in Fig. 8.

FIG. 13—Remarkable Compression and Shear Effects Along One of the Fault Cracks, Produced on Elevated Grounds Near Pt. Arena. A Foot-Scale Placed in the Foreground Shows the Size of the Overlapping Earth Pieces, Whose Plan Is Given in Fig. 8.

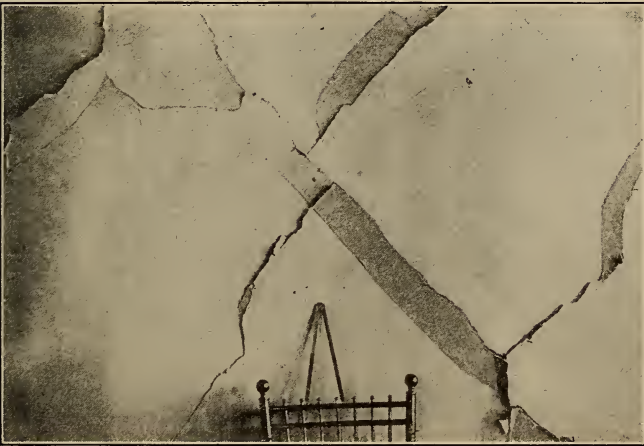
Fig. 14 (Pl. IV) illustrates some of the cracks of plastered walls observed in St. James Hotel, San José.

FIG. 14—Some of the Cracks of Plastered Walls, in St. James Hotel, San José.

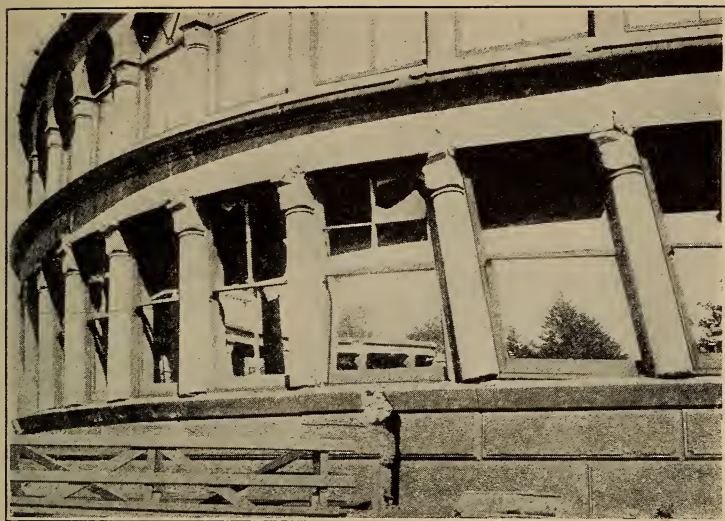
Fig. 17 (Pl. VI) gives an outside view of the back part of the Observatory on the top of Strawberry Hill, in the Golden Gate Park, San Francisco. This building is of reinforced concrete and furnishes a good demonstration of the strength of such structures. The Observatory was indeed seriously damaged and its front portion fell down to the ground, but this was on account of the weakness of the foundation ground, which was mostly a filled-up one and was considerably cracked and depressed. Fig. 18 shows, in a larger scale, one of the cracks of the basement wall, similar to that shown in Fig. 17. The steel cable, one inch in diameter, which was embedded in the concrete, was broken. The use of steel cables in concrete walls thus seems to be objectionable, as they are more liable to rusting than solid steel bars. None of the latter used in the concrete walls and floor of the Observatory, whose section was half inch square, was found broken; the adhesion of concrete and steel being also very good.

FIG. 17—*The Observatory on the Top of the Strawberry Hill, in the Golden Gate Park, San Francisco, Built of Reinforced Concrete. An Outside View of the Back Part.*

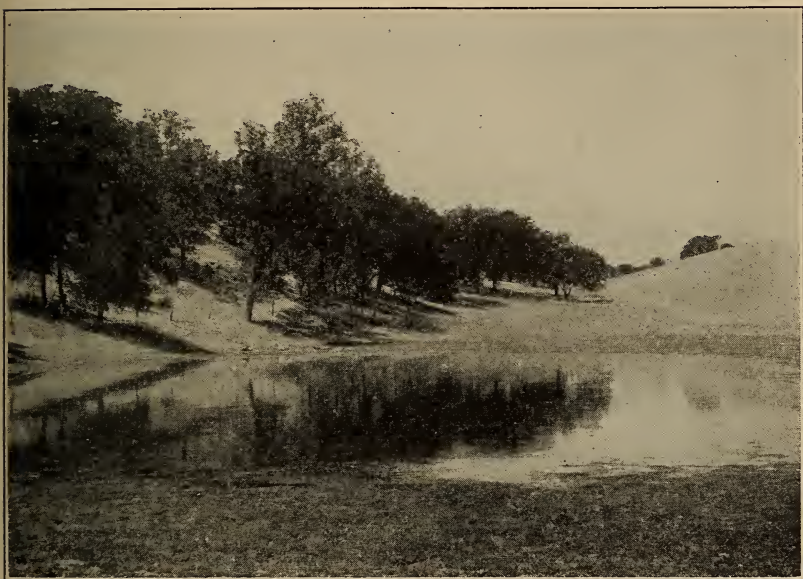
Lake in a Sunken Area on the Rift in Cholame Valley.

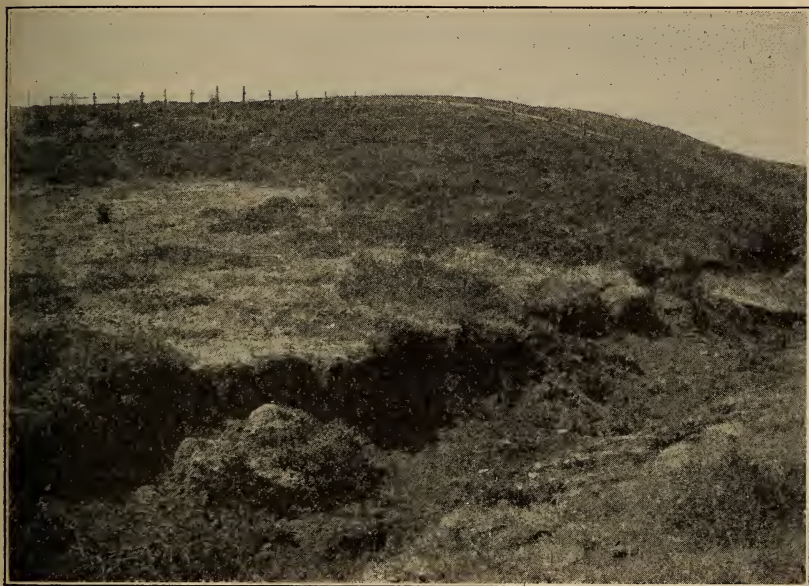
Effect of Recent Earthquake in the Ridge Above Mussel Rock.

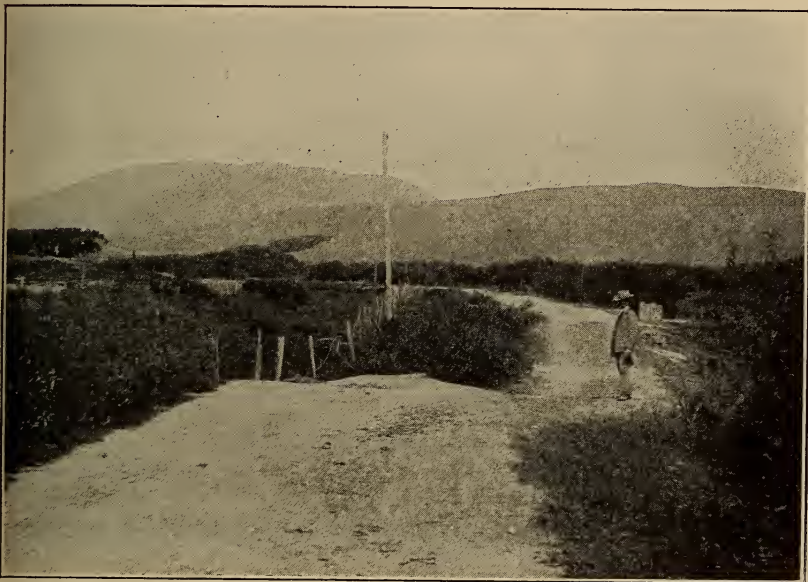
Road Displaced 12 Feet on Line of Rift at Head of Tomales Bay.

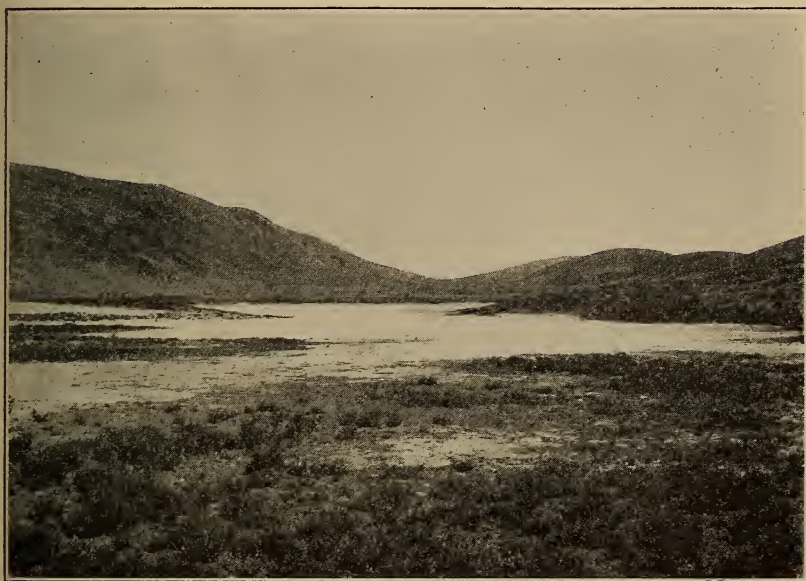
Alkali Sink on Line of the Rift North of Bakersfield.

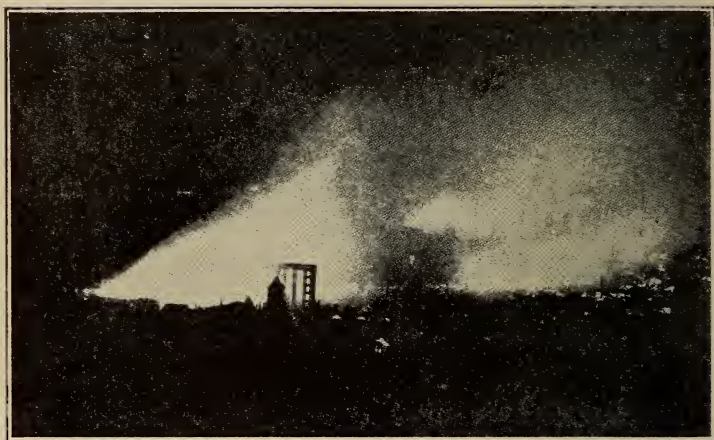
San Francisco on the Night of April 18.

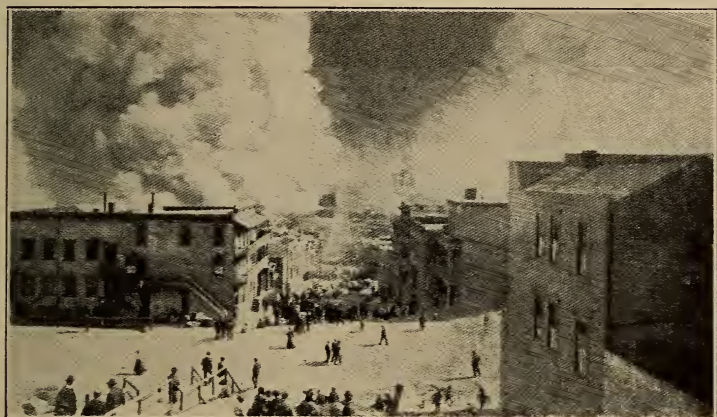
Looking Southeast from Telegraph Hill During Fire

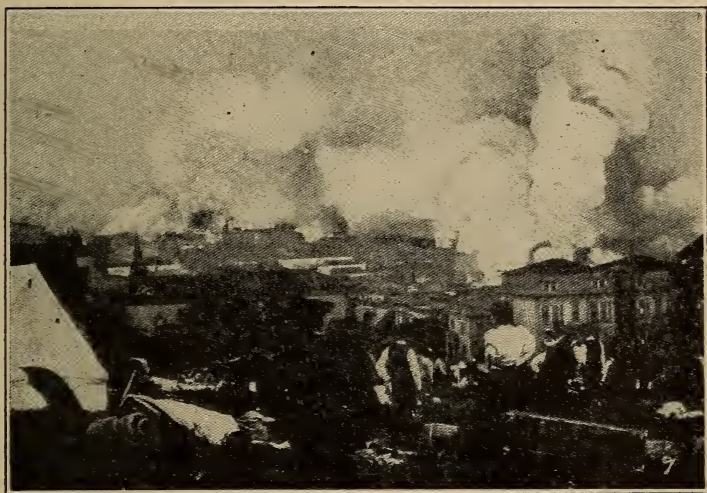
Looking South from Lafayette Square, 4 p. m. April 18

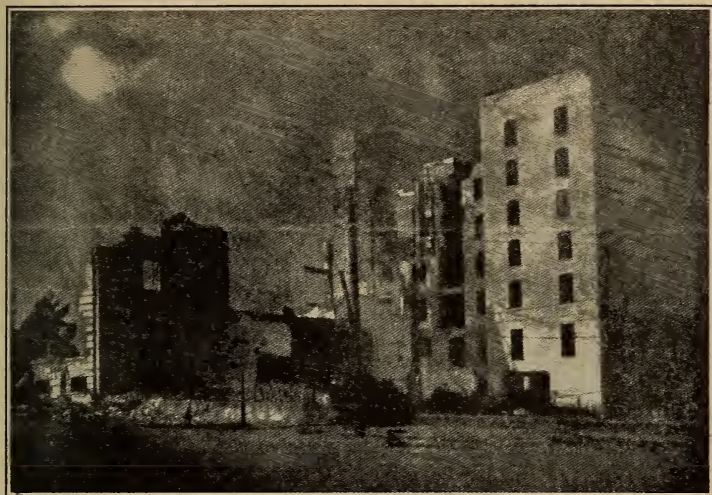
Van Ness Avenue, 10:30 p. m. April 19

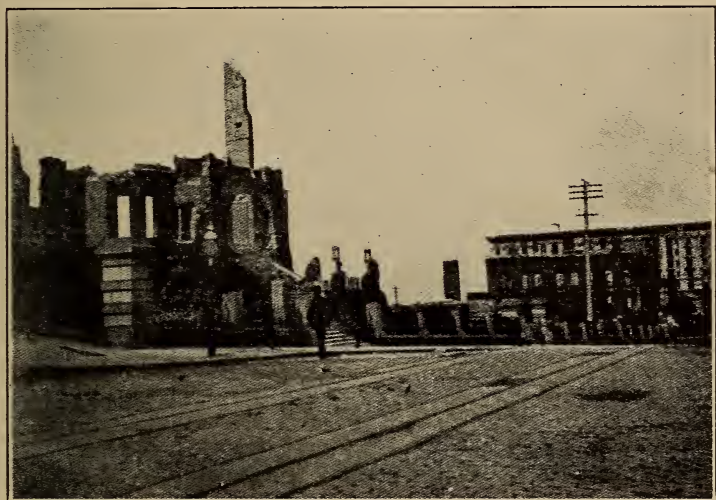
"Nob Hill" After the Fire, Showing the Huntington, Crocker, and Flood Residences. Fairmont Hotel in Background.

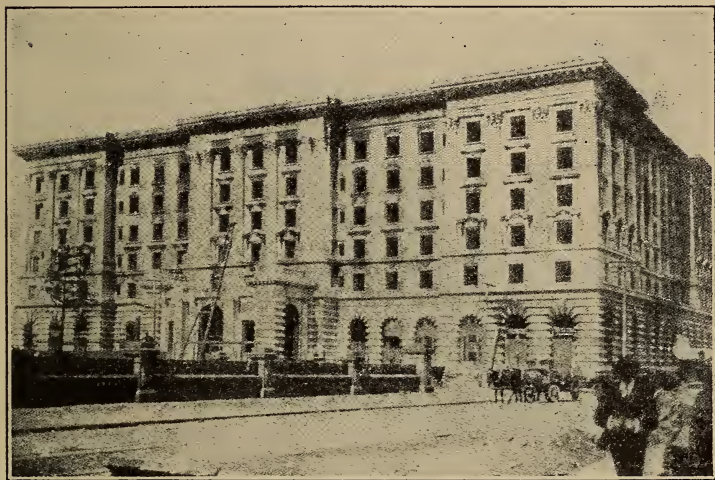
Fairmont Hotel After the Fire
